FUTURE GRAPHICS

Receiving Inspection Criteria
HP 51649A Cartridge

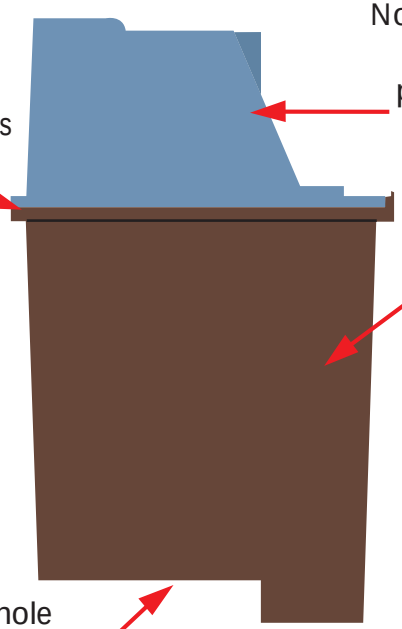
SIDE VIEW

No cracks or openings at joint.

No cracks in the plastic case.

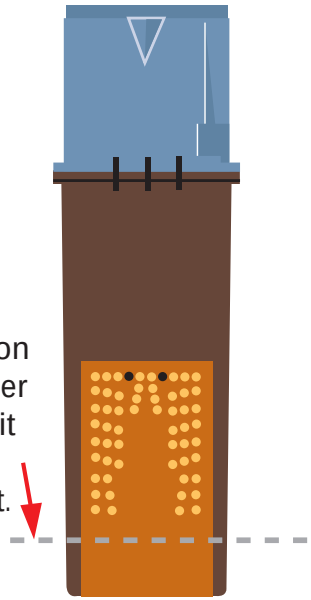
CONTACT SIDE VIEW

No delamination or ink under flex circuit beyond this point.

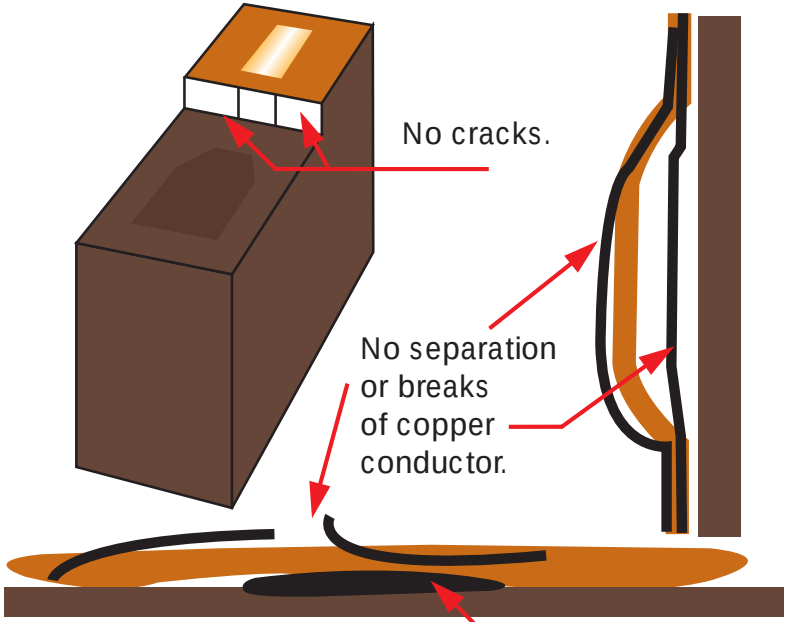
No cracks.

No separation or breaks of copper conductor.

Ink under delaminated flex circuit.

Maze hole cover not delaminated.
