Receiving Inspection Criteria HP 1823A/41A/78A/6625A Cartridges

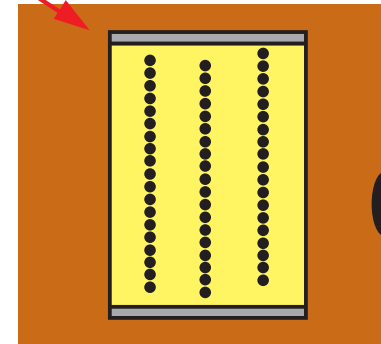
SIDE VIEW

No delamination or flex cable from plastic case beyond this point.

HP label must be on cartridge

No cracks in the plastic case.

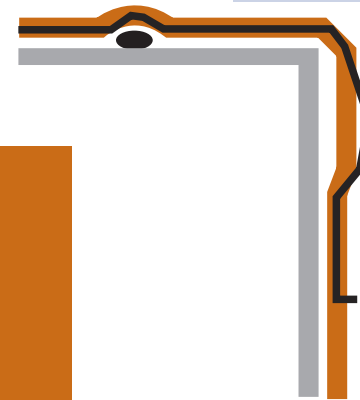
CONTACT SIDE VIEW

No corrosion on the contacts. no cuts in the flex cable.

No ink under flex circuit in this area.

No delaminated conductors for flex circuit.

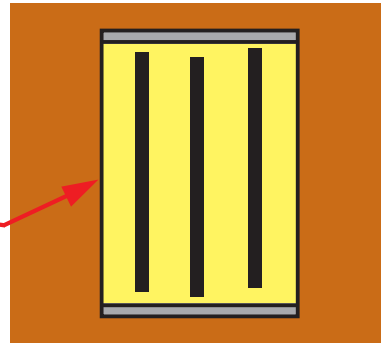
Nozzle Plate Side

No holes or deep scratches in the nozzle plate. No delamination.

Nozzle plate not lifted, loose or missing.

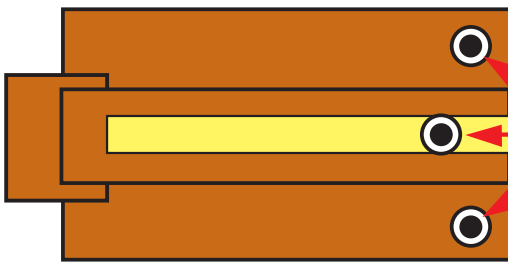
Plugs not removed no additional holes in top.
